ACCIDENT RECONSTRUCTION REPORT

NCTI File Number: NC061218

March 25, 2020

Case Re: Jeremy Farris v. Brian Dana Jefferson, Michael Bishop, and National
Liability and Fire Insurance Company
US District Court, Western District of Louisiana, Lafayette Division
Civil Action No. 6:19-cv-108
Date of Accident: June 12, 2018
NCTI File: NC061218

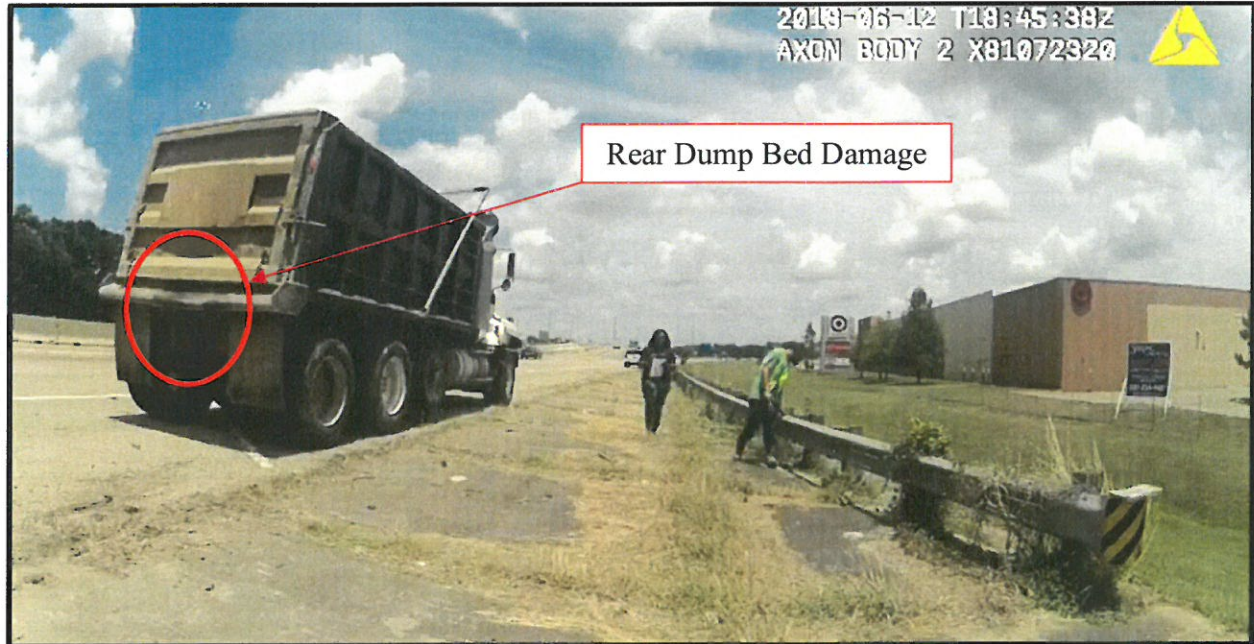
Figure 4: Mr. Farris' Dump Truck from Body Camera Footage

NCTI did not have the opportunity to inspect either of the vehicles and has not received any photographs of the damages other than what is depicted in the footage from Mr. Jefferson's dash camera and the investigating officers' body cameras. This body camera footage depicts minor damage to the rear of the dump bed of Mr. Farris' Dump Truck and to the front grille of Mr. Jefferson's 18-Wheeler. This damage is consistent with a rear-end collision at a low closing speed. See Figures 4 and 5.

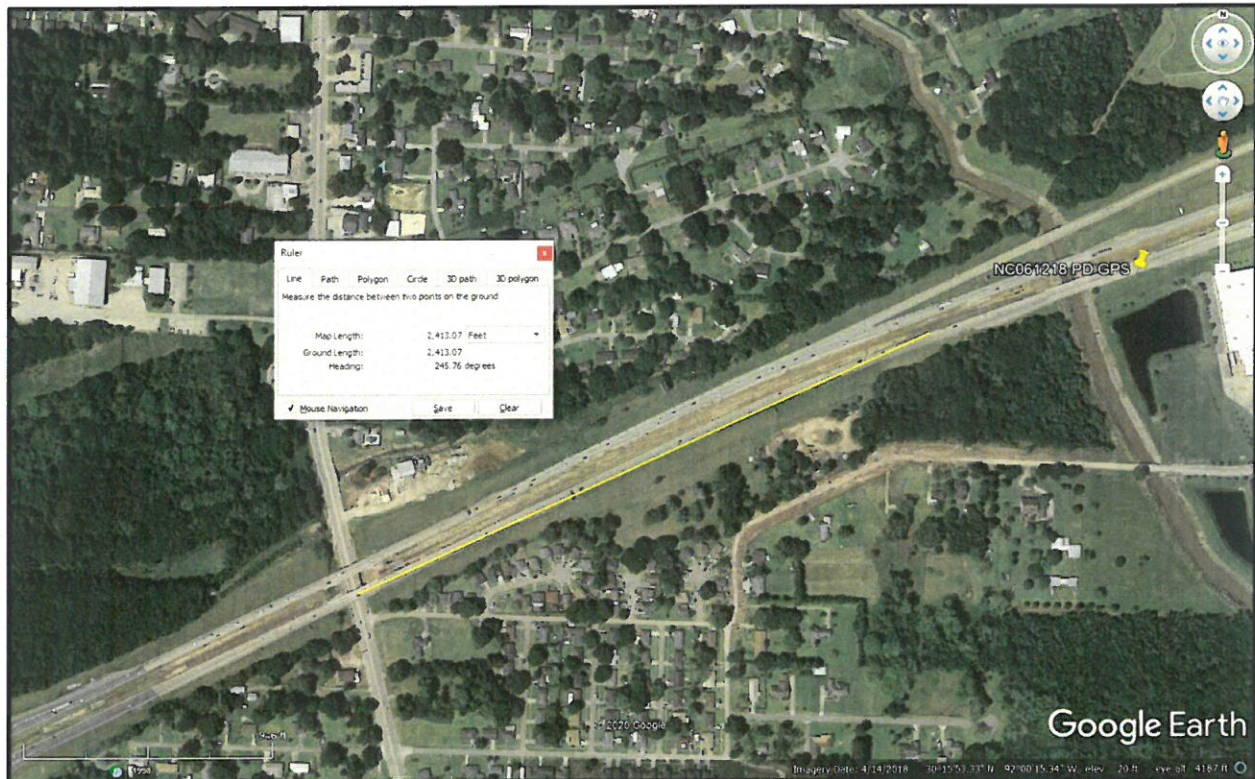
Figure 10: Sightline Measurement from Google Aerial

Based on Google Aerial and street views, there was a clear sightline in the area. NCTI determined that an eastbound vehicle should be able to see the gap that Mr. Farris' dump truck pulled out of from approximately 2400ft away (nearly half a mile). See Figure 10.

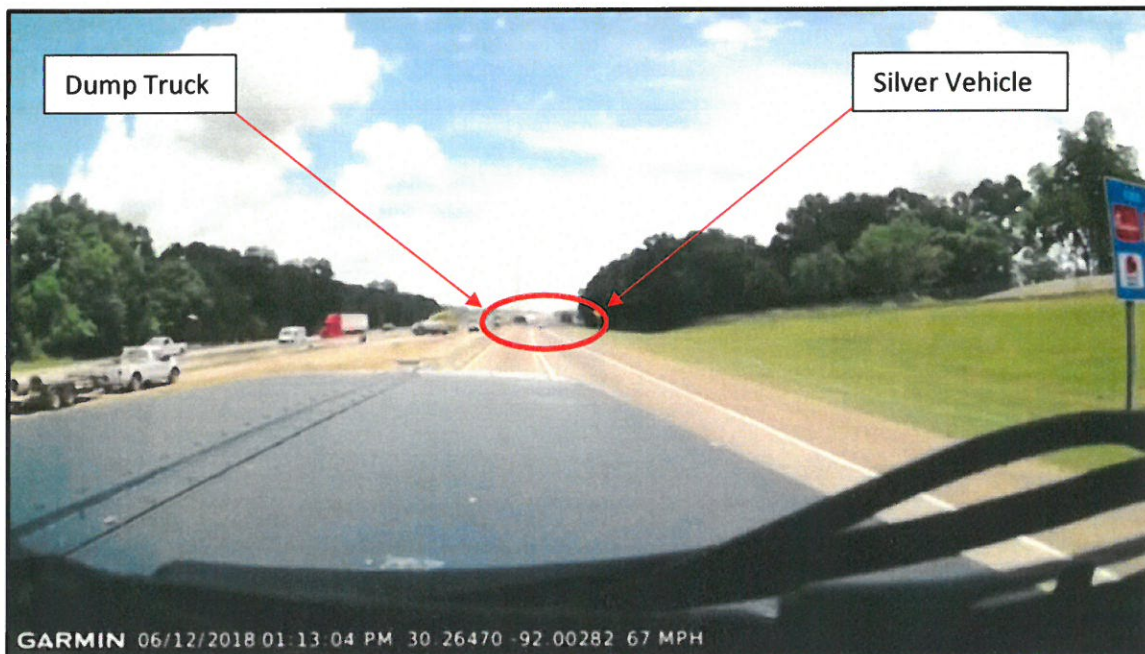
Figure 23:
Dump Truck Enters I-10, 11.5sec before Impact, 67mph

At 1:13:04 PM, Mr. Farris' Dump Truck can be seen entering the left lane from the center median barrier opening within the construction zone. A silver vehicle in the right lane can be seen passing the barrier opening where Mr. Farris began his entry onto the left lane, consistent with Mr. Farris' testimony that a silver car passed by before he started turning. See Figure 23.

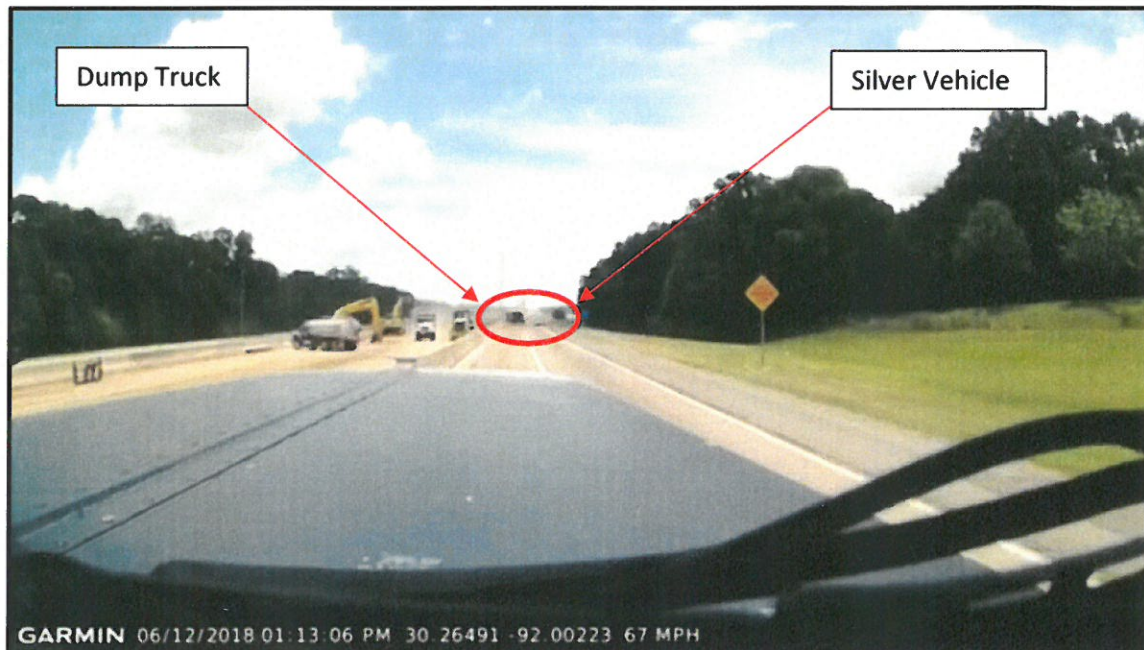
Figure 24:
18-Wheeler Begins Braking, 9.5sec before Impact, 67mph

Two seconds later, at 1:13:06 PM, Mr. Jefferson is going 67mph when he begins reducing his speed as indicated on the video display as well as the audio recording that captures the loud exhaust noise typical of a Compression Release Engine Brake, or Jake Brake. See Figures 24 and 25.

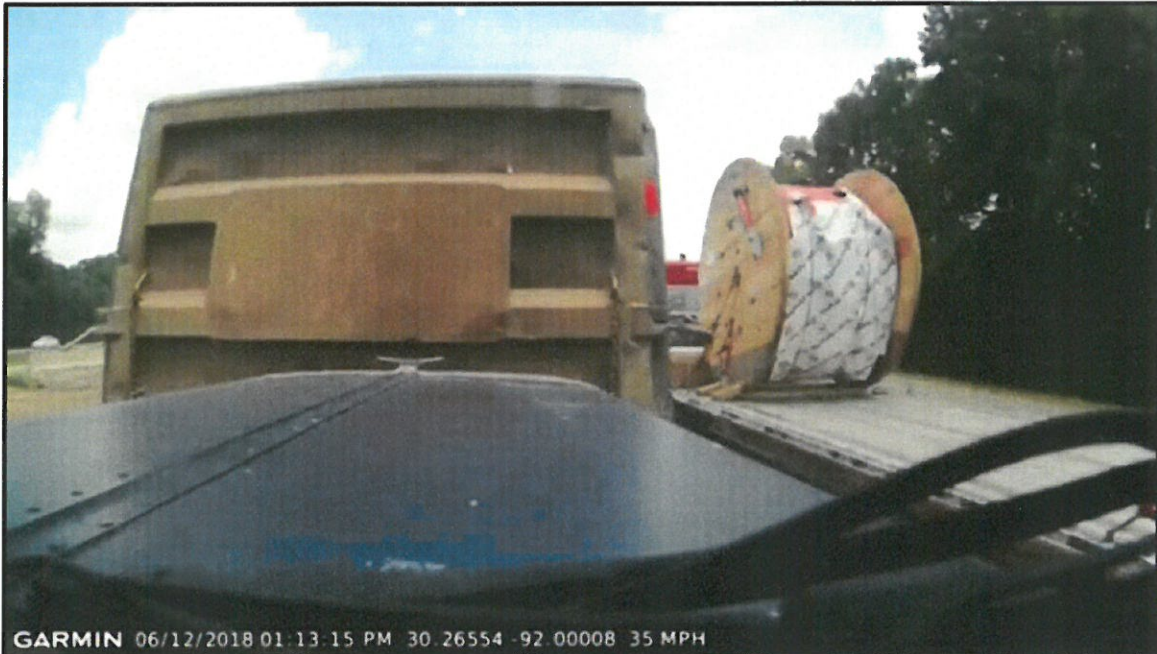
Figure 26:
Impact, 35mph

Approximately 9.5sec after Mr. Jefferson began reducing his speed from 67mph, at 1:13:15 PM Mr. Jefferson impacts the rear of Mr. Farris' dump truck at 35mph. See Figure 26.

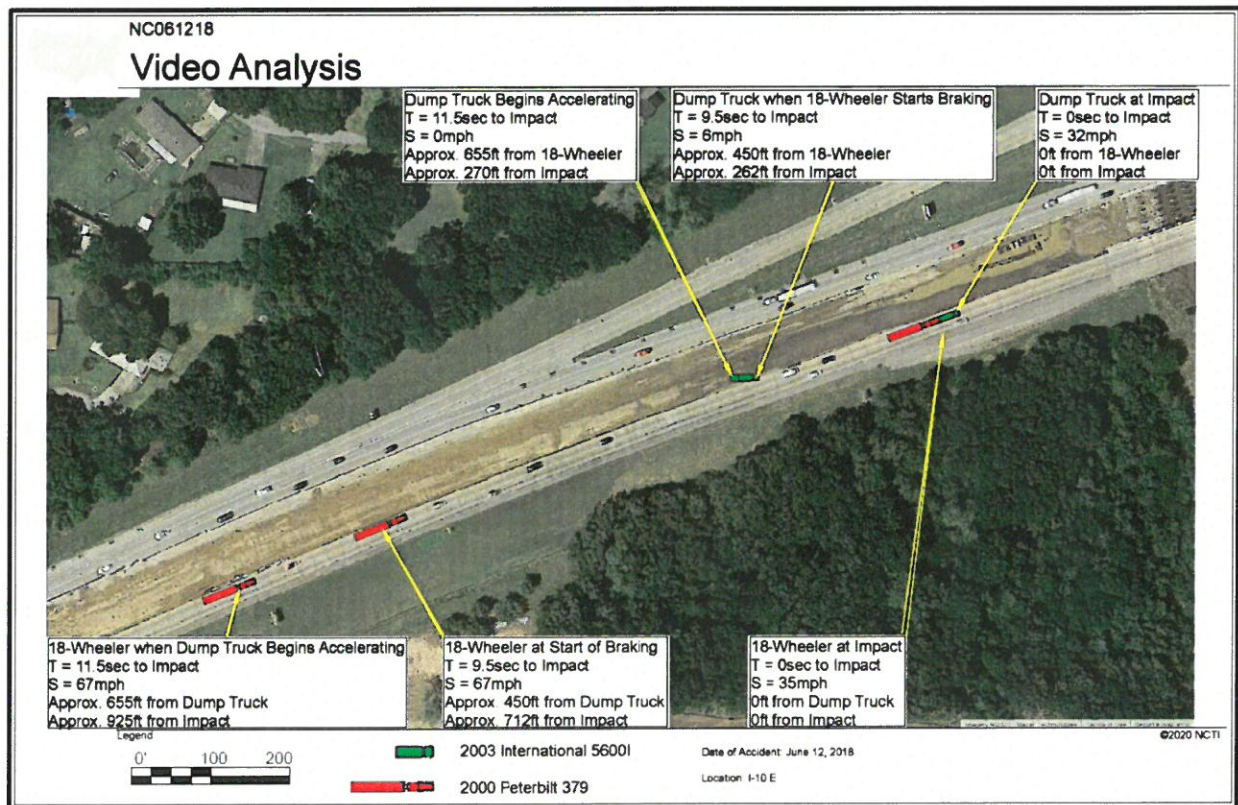
Figure 28:
Video Analysis CAD

The time-distance relationship of the two vehicles was determined based on analysis of the dash camera video and calculations. Impact occurred approximately 11.5sec after Mr. Farris had entered the left travel lane traveled approximately 270ft reaching a speed of approximately 32mph. Mr. Farris' average acceleration rate was 0.13g, normal for an unloaded dump truck, and his speed at impact was 32mph. This is consistent with Mr. Farris' testimony that he was traveling at 30-35mph at impact. Mr. Jefferson, going 67mph, was approximately 655ft away when Mr. Farris began entering I-10. See Figure 28.

Mr. Jefferson's dash camera video shows that he gradually slowed from 67mph to 35mph in 9.5sec while traveling approximately 712ft, which equates to a braking rate of only 0.15g, (lower than a normal value 0.2g). This low rate of speed reduction, combined with the audible recording of the loud engine exhaust noise, suggests that Mr. Jefferson only applied the Jake Brake, (a component installed on diesel engines that releases stored, compressed air from the cylinder at the top of the piston's stroke, preventing it from returning it's energy to the crankshaft and powering the down-stroke, slowing the vehicle as the air is compressed). Many drivers prefer to use only the Jake Brake as they extend the life of service brake shoes and prevent them from overheating.²

Had Mr. Jefferson simply applied the service brake, (brake pedal) in lieu of improperly relying on the Jake Brake, a normal application of braking (0.21g) would have enabled him to come to a complete stop within the same distance that he actually traveled. Alternatively, applying the brake pedal at an even lesser rate than normal, (0.16g), would have enabled Mr. Jefferson to reduce his speed to match that of Mr. Farris, 32mph, and no impact would occur.
